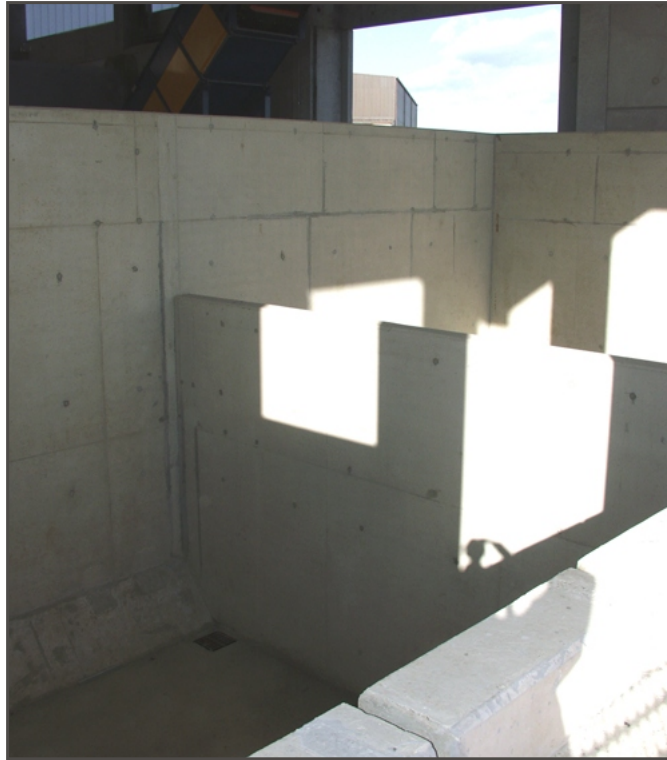
**Plate 3.1:** Residual MSW Reception Pits under construction (Frog Island, October 2005).

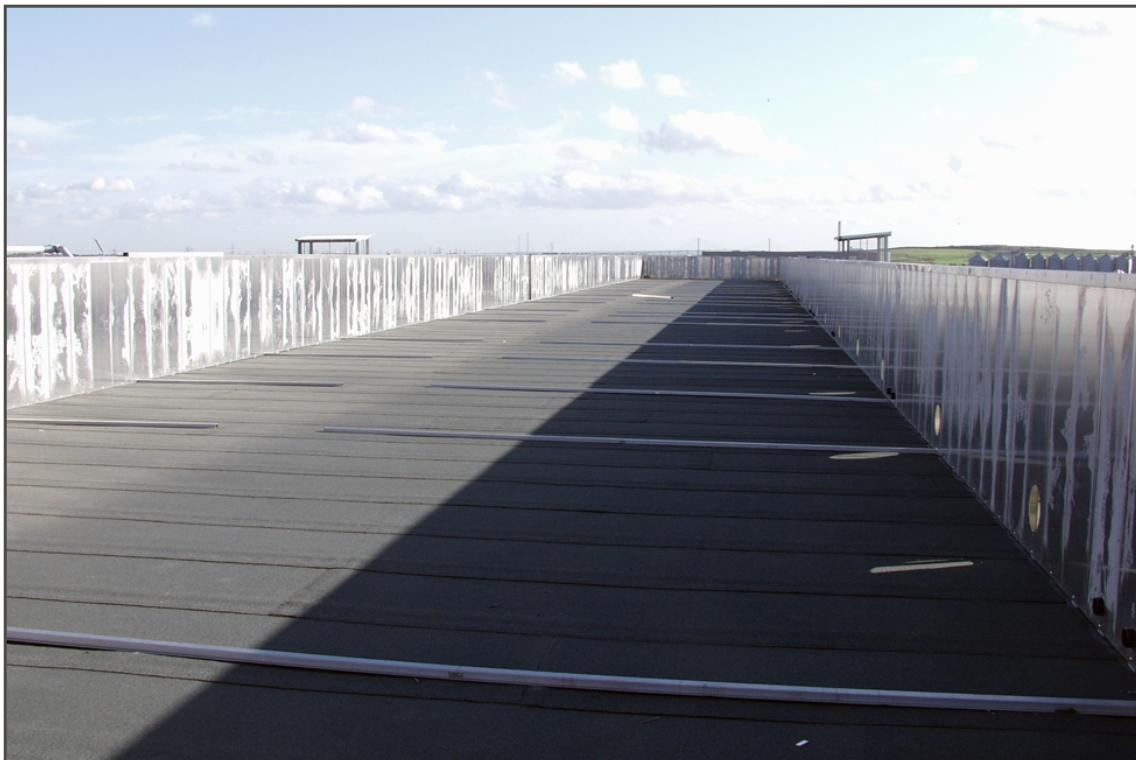
**Plate 3.2:** Biofilter under construction (Frog Island, October 2005).

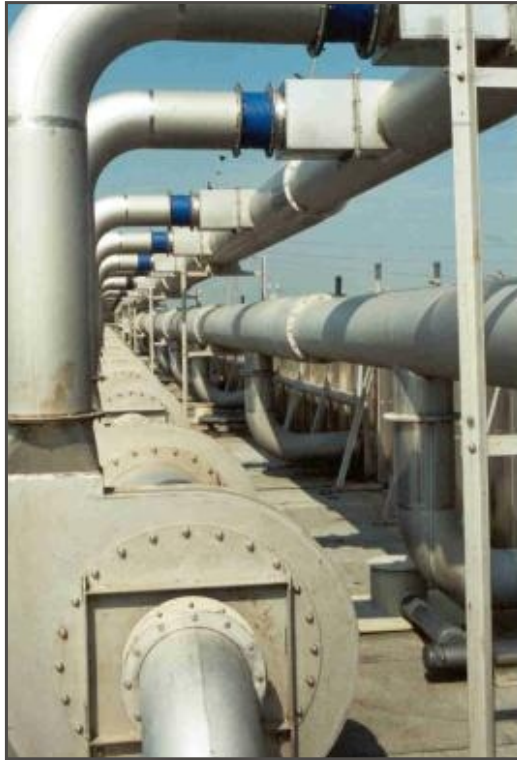
**Plate 3.3:** Illustration of roof-mounted ductwork to biofilter (operational plant, Italy).

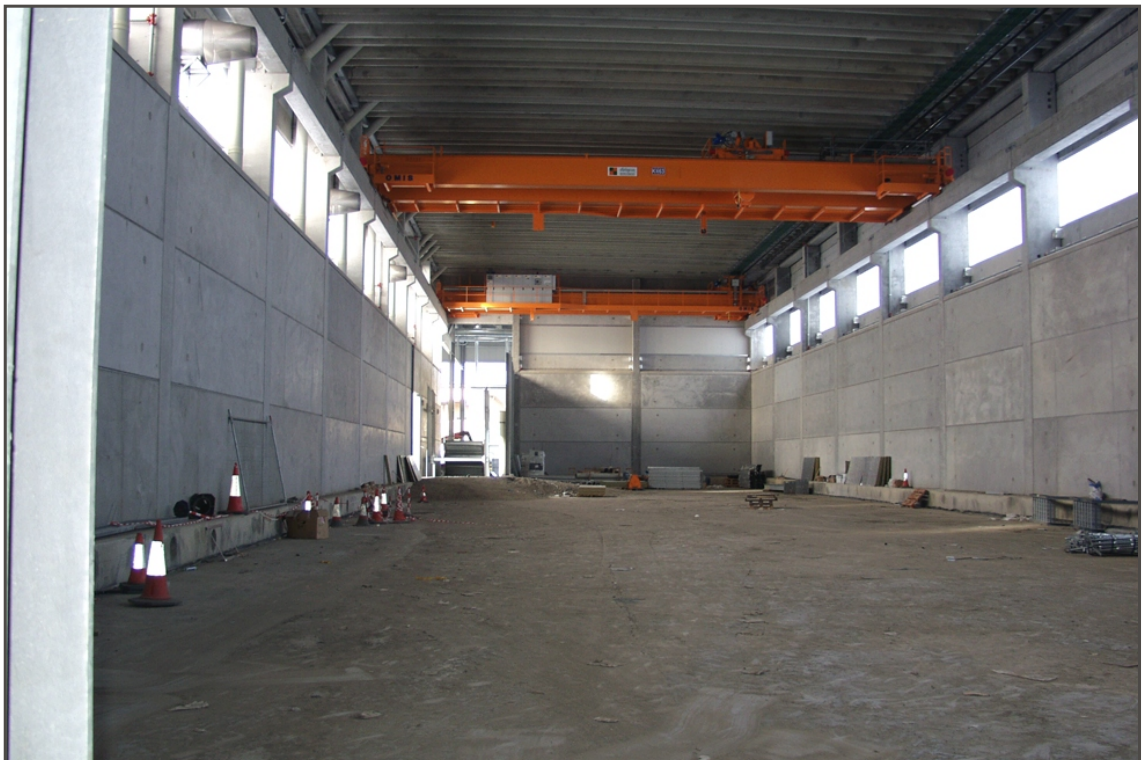
**Plate 3.4:** Overhead Cranes under construction (Frog Island, October 2005) within biodrying area.

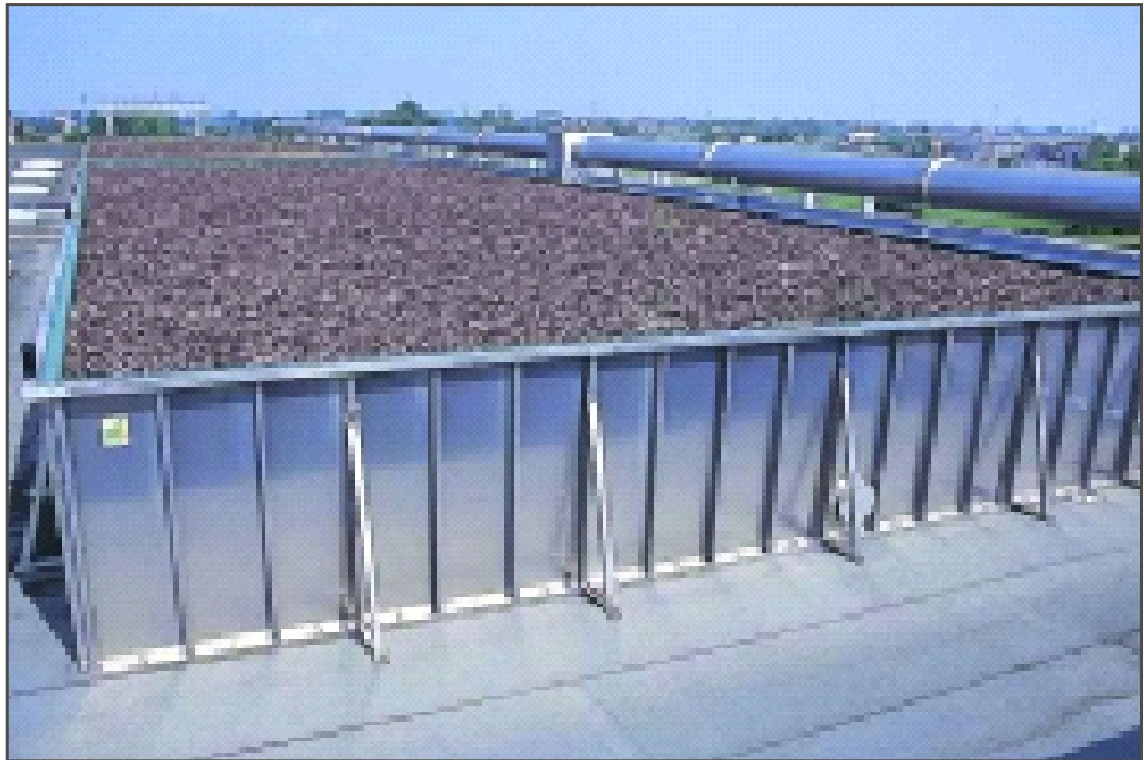
**Plate 3.5:** Operational roof mounted biofilter (Italian plant).
